# State of Utah DEPARTMENT OF NATURAL RESOURCES Division of Oil, Gas & Mining

**Inspection Report** Minerals Regulatory Program September 22, 2009

Mine Name: Eagle Canyon Permit number: M/015/0050 Operator Name: Georgia Pacific Inspection Date: July 7, 2009 Time: 2:00-2:20 PM

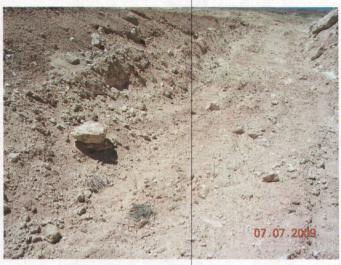
visible in this photo, but there are not many.

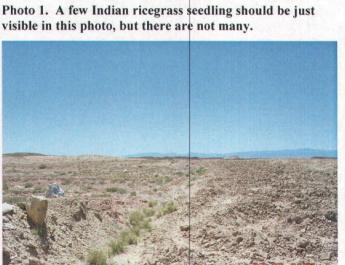
Photo 2. Contrast between an area that was regraded and an area that was not re-disturbed.

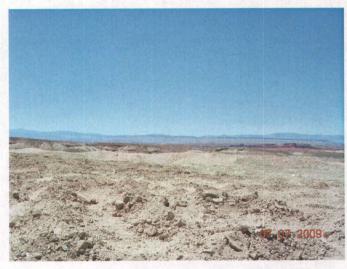
Photo 3. An overview of part of the regraded area.
